Black Point Beach Association Report Pier/Groin Structures October 2020

The Black Point Beach Association (BPtBA) maintains four erosion/beach control structures at their beach areas fronting the west side of Niantic Bay on Long Island Sound along with a drainage pipe outlet.

This report is intended as a point in time evaluation of the following existing structures:

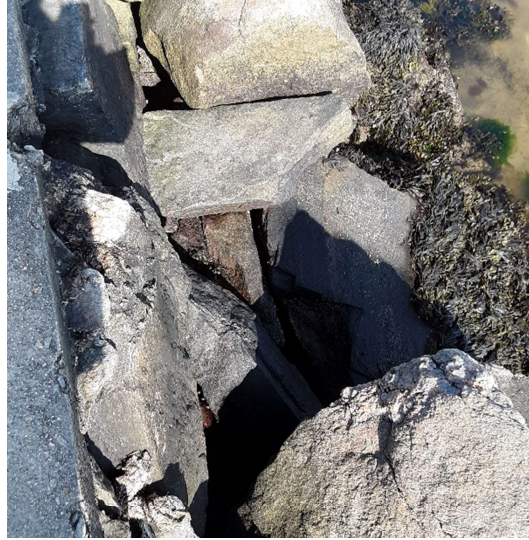
The effectiveness of this type of revetment structure to wave action is determined by the use of appropriate size stone and maintaining a uniformly consistent plan profile with irregular surface towards the wave direction. When waves are sufficient to displace the exposed stone the created gaps along the revetment can exacerbate additional displacements and lead to deterioration of the protection. Additionally, deterioration of the concrete paving and or integrity of the cut stone pier walls can lead to breakdown of the pier with loss of core materials within.

Gap in Armor Stone Revetment Requiring New Stone Infill

For Piers A,C and D there are areas where the armor stone has gaps which need to be filled to provide an effective profile. This should be done with appropriate size stone and we recommend pieces weighing at least 2400 lbs. minimum with angular proportions. Stone should be placed to provide interlock with adjacent stones and placed to provide an approximate 2 to 1 horizontal to vertical slope. Approximate areas of this work are shown on the attached plan layouts of the piers. Stone replacement and void infills should be accomplished with new stone, not reclaimed stones from the front of the revetment as this could destabilize the structure and this work should be undertaken in a timely fashion such as in the next 5 years.

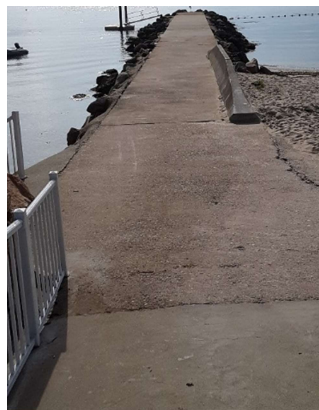
North Groin Paving

The concrete paving appears to be of different ages and is worn but serviceable. Maintenance should be considered in areas where joints are opening and or where vegetation is growing. This will slow down further deterioration and avoid tripping hazards on the deck.

Repair for these deteriorated conditions would include removal of any loose cracked/crumbling concrete with new patching placed with depth and bonding to adhere to the substrate concrete. We would also recommend removal of any vegetation growing within joints in the paving as this will speed up deterioration at these joints. This type of work should be considered yearly maintenance provided on an as needed basis.

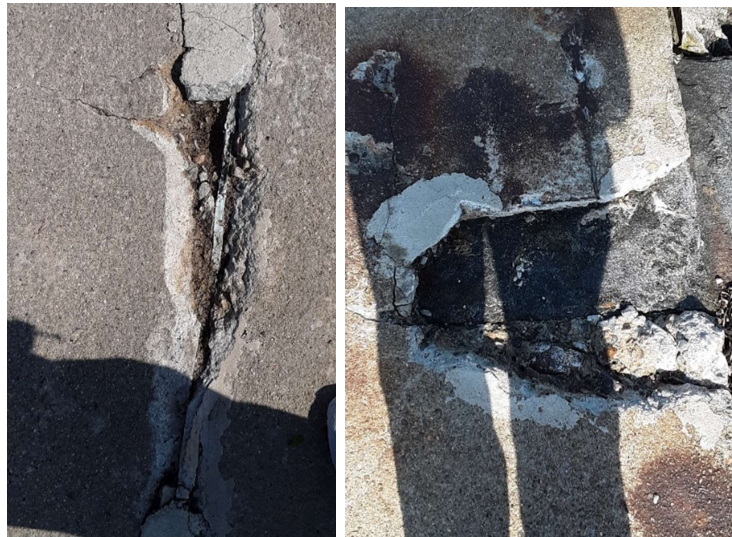
Paving Deterioration

Paving Pothole

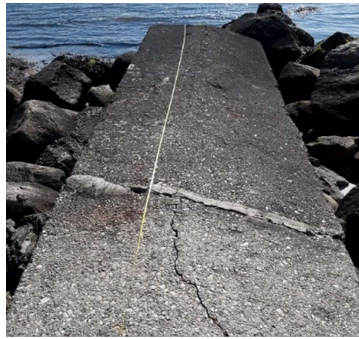
The concrete cap structure is intended to provide protection of an approximate 30 inch diameter precast concrete pipe that drains street runoff into the bay. It has a cast-in-place concrete covering over the top and sides from some distance landward out to the discharge end which is partially surrounded by stone to prevent clogging from sand and small stones. The last 21 feet of the enclosure and pipe have broken and settled away from the landside section with a break and separation at the last section. This has allowed the discharge end to shift (rotate counterclockwise 20 degrees or so) and thus compromised the pipe and its hydraulic cross-section limiting its function. Further deterioration will eventually cause the drainage to become clogged.

Drainage Pipe Concrete Encasement

We would recommend that the end section of this pipe be replaced with new concrete encasement established back to the break (approximately 21 feet) as soon as possible.

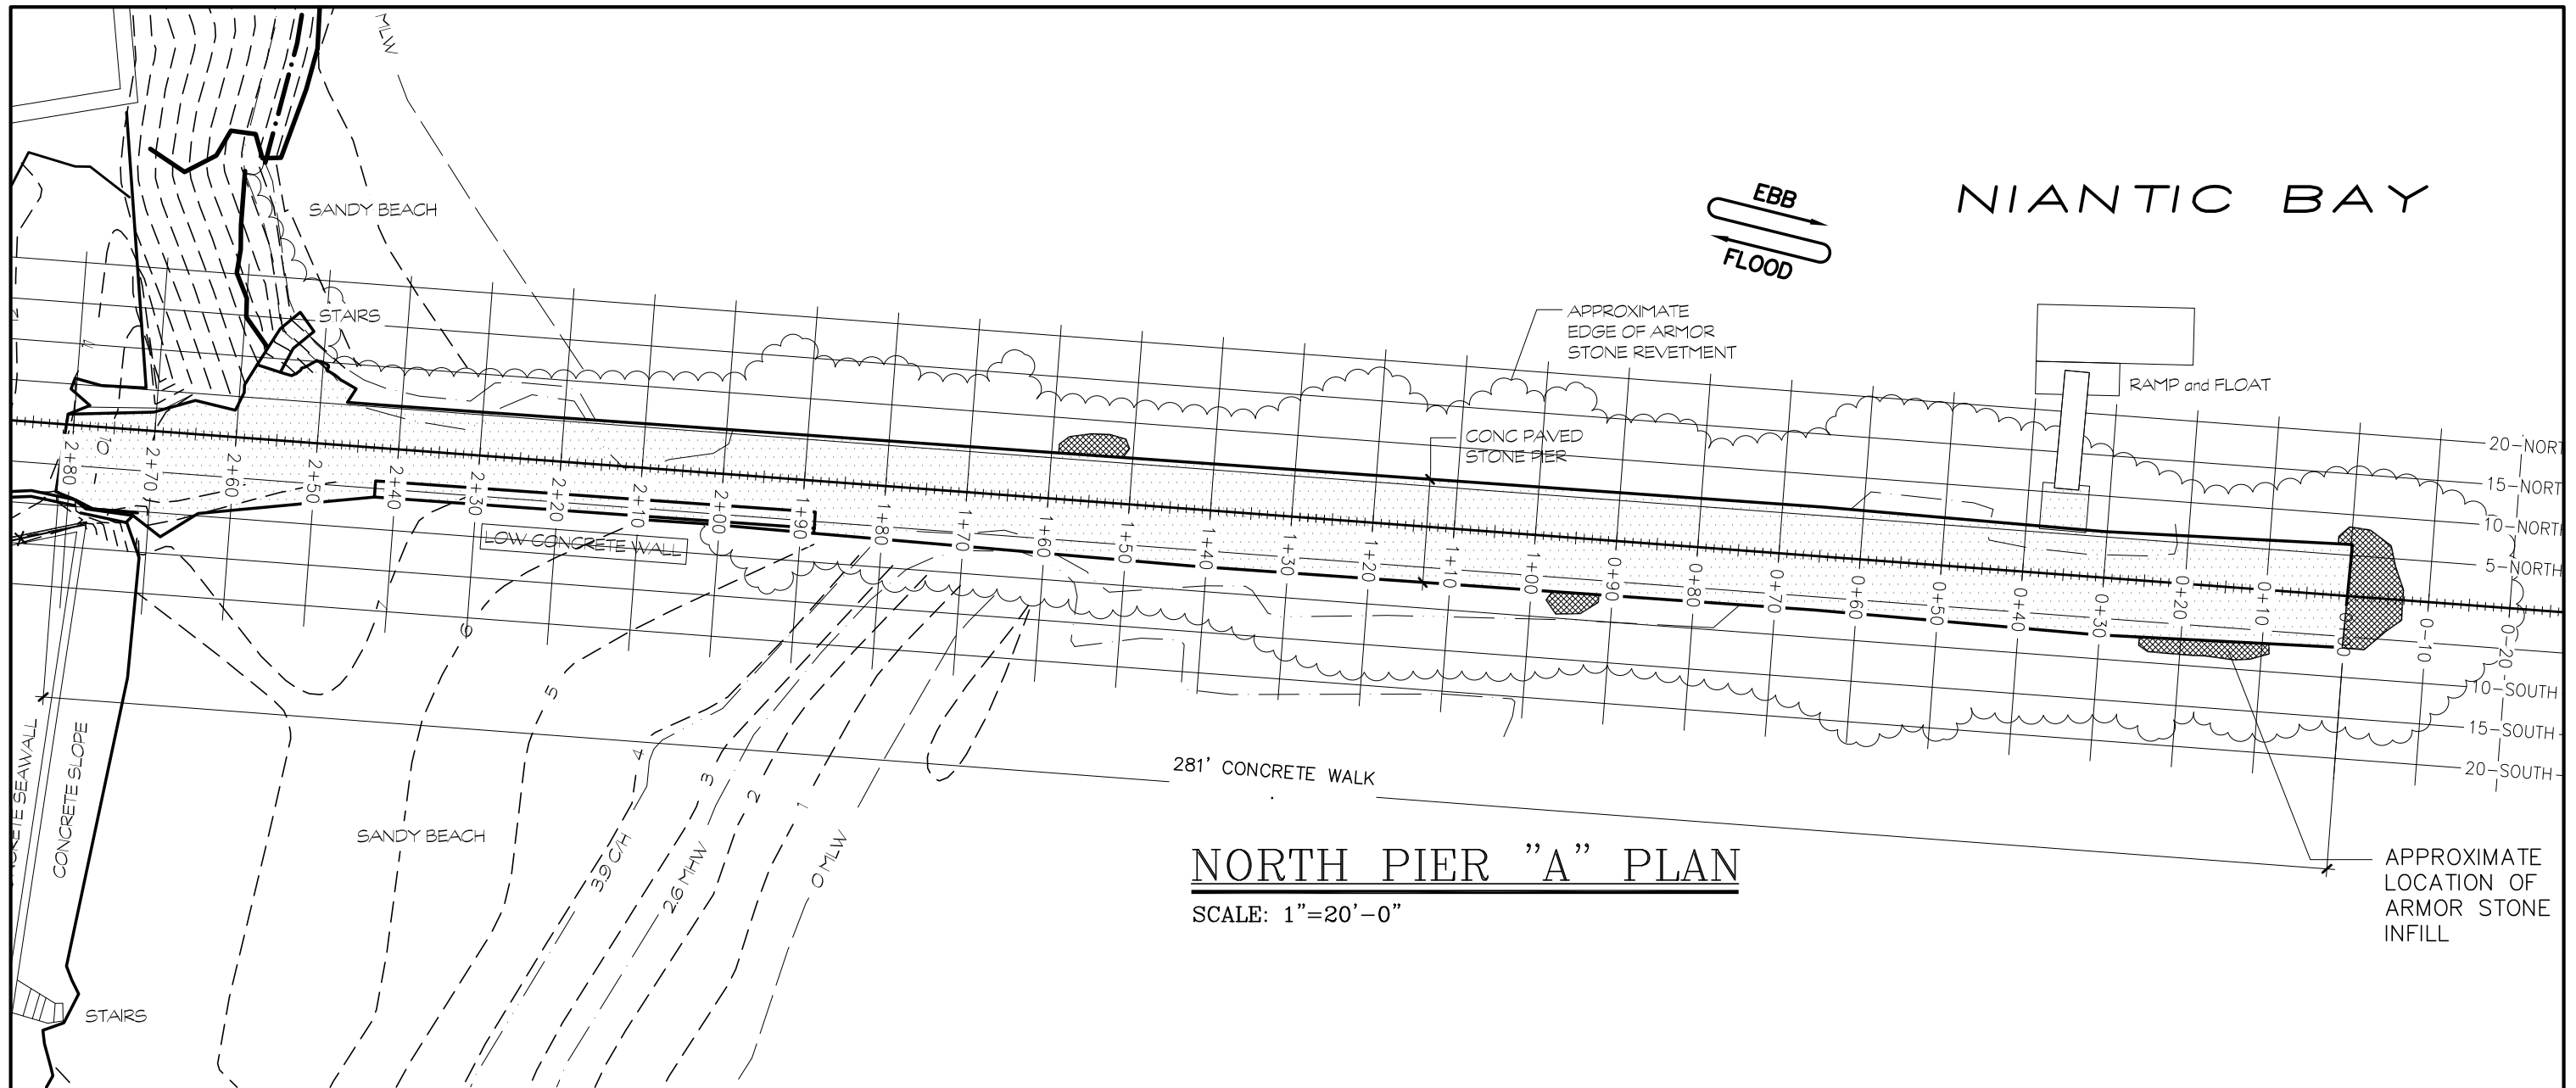
NORTH PIER "A" PLAN

APPROXIMATE LOCATION OF ARMOR STONE INFILL

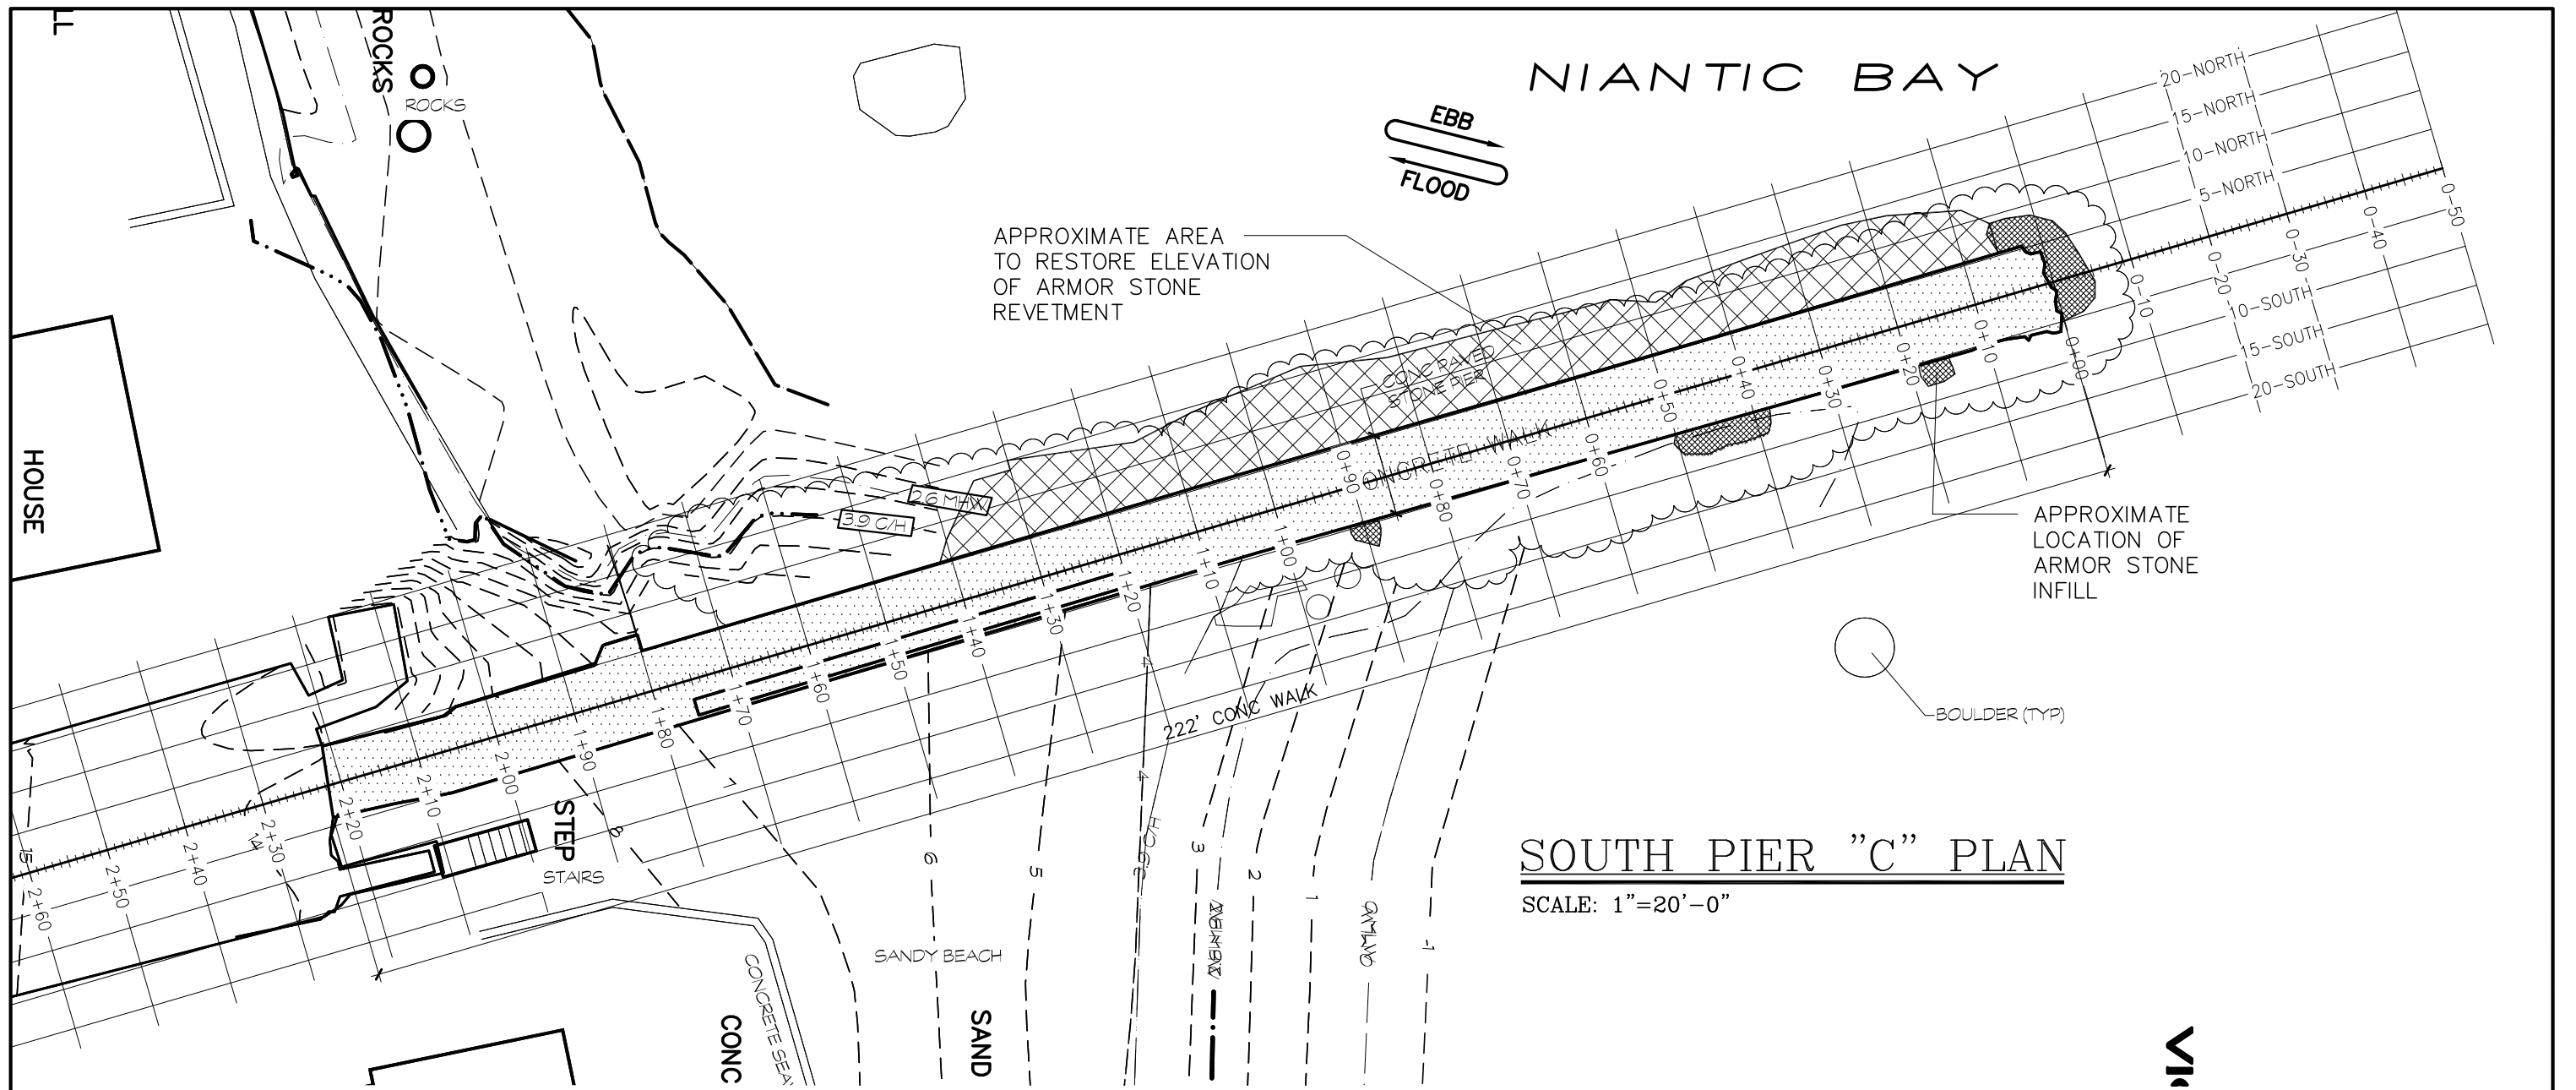
SOUTH PIER "C" PLAN
 SCALE: 1"=20'-0"

All piers have undergone some degree of settlement. The most crucial settlement condition exists on the northern side of the South Pier "C" where the revetment appears to be up to 2 feet lower than the concrete paving. We attribute this to storm waves overtopping the groin from the south predominate wave fetch direction with the subsequent removal of the sands beneath the northern revetment. Continued wave action will jeopardize the stability of the groin and we would recommend restoring the height of this with armor stone as of size and conditions noted previously. This work should be undertaken with the next 5 years to safeguard this pier.

Enhance Armor Stone: For Pier C only - Full permit and raise stone on North Side of South Pier per SK2

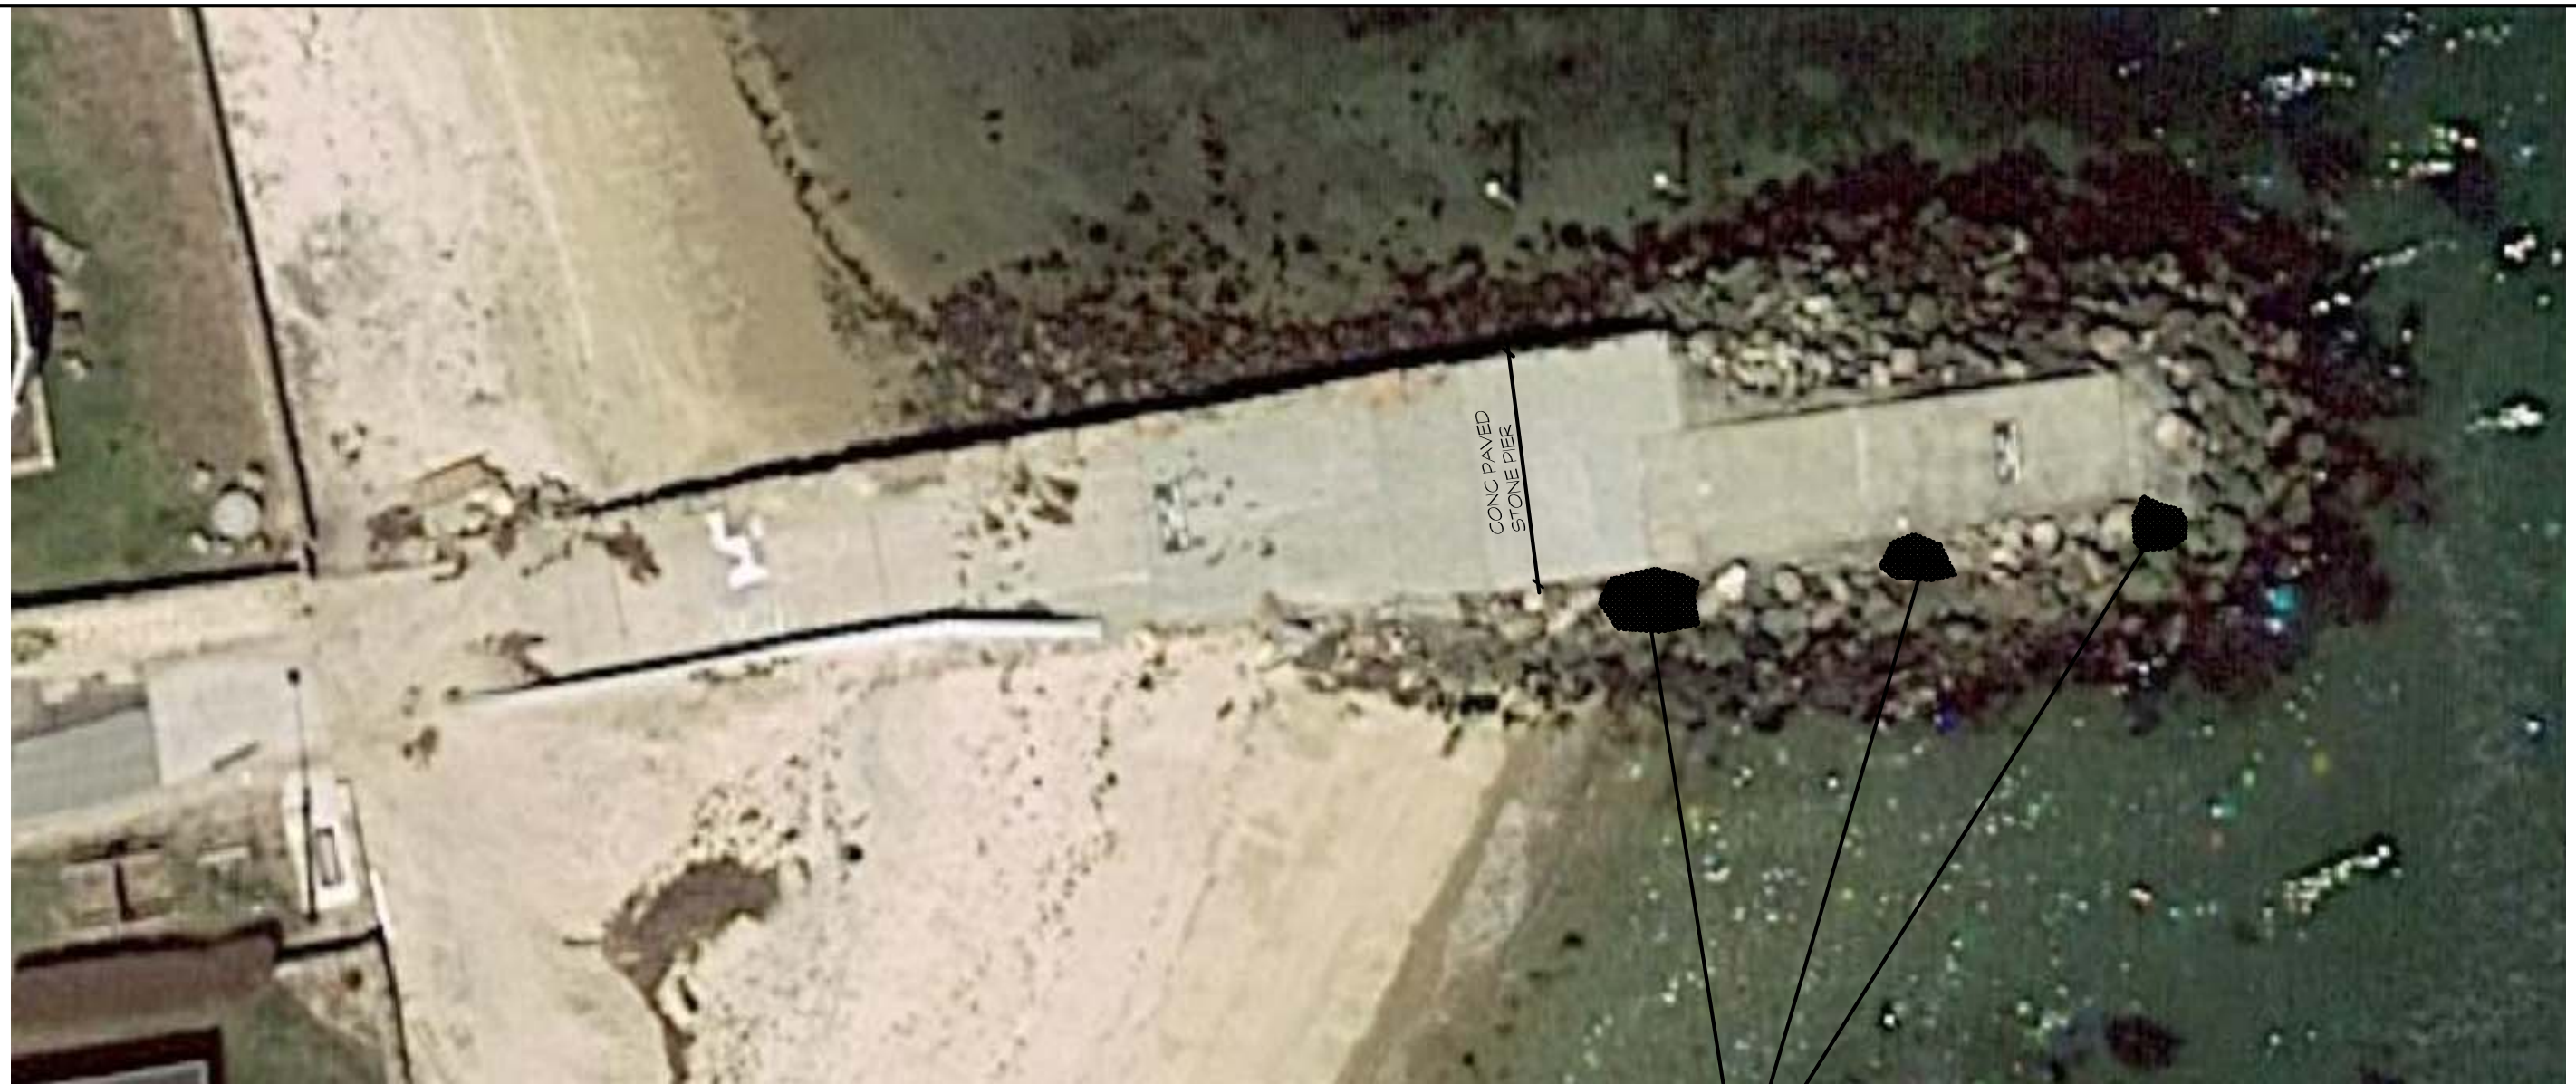
PIER "D" PLAN

APPROXIMATE
LOCATION OF
ARMOR STONE
INFILL

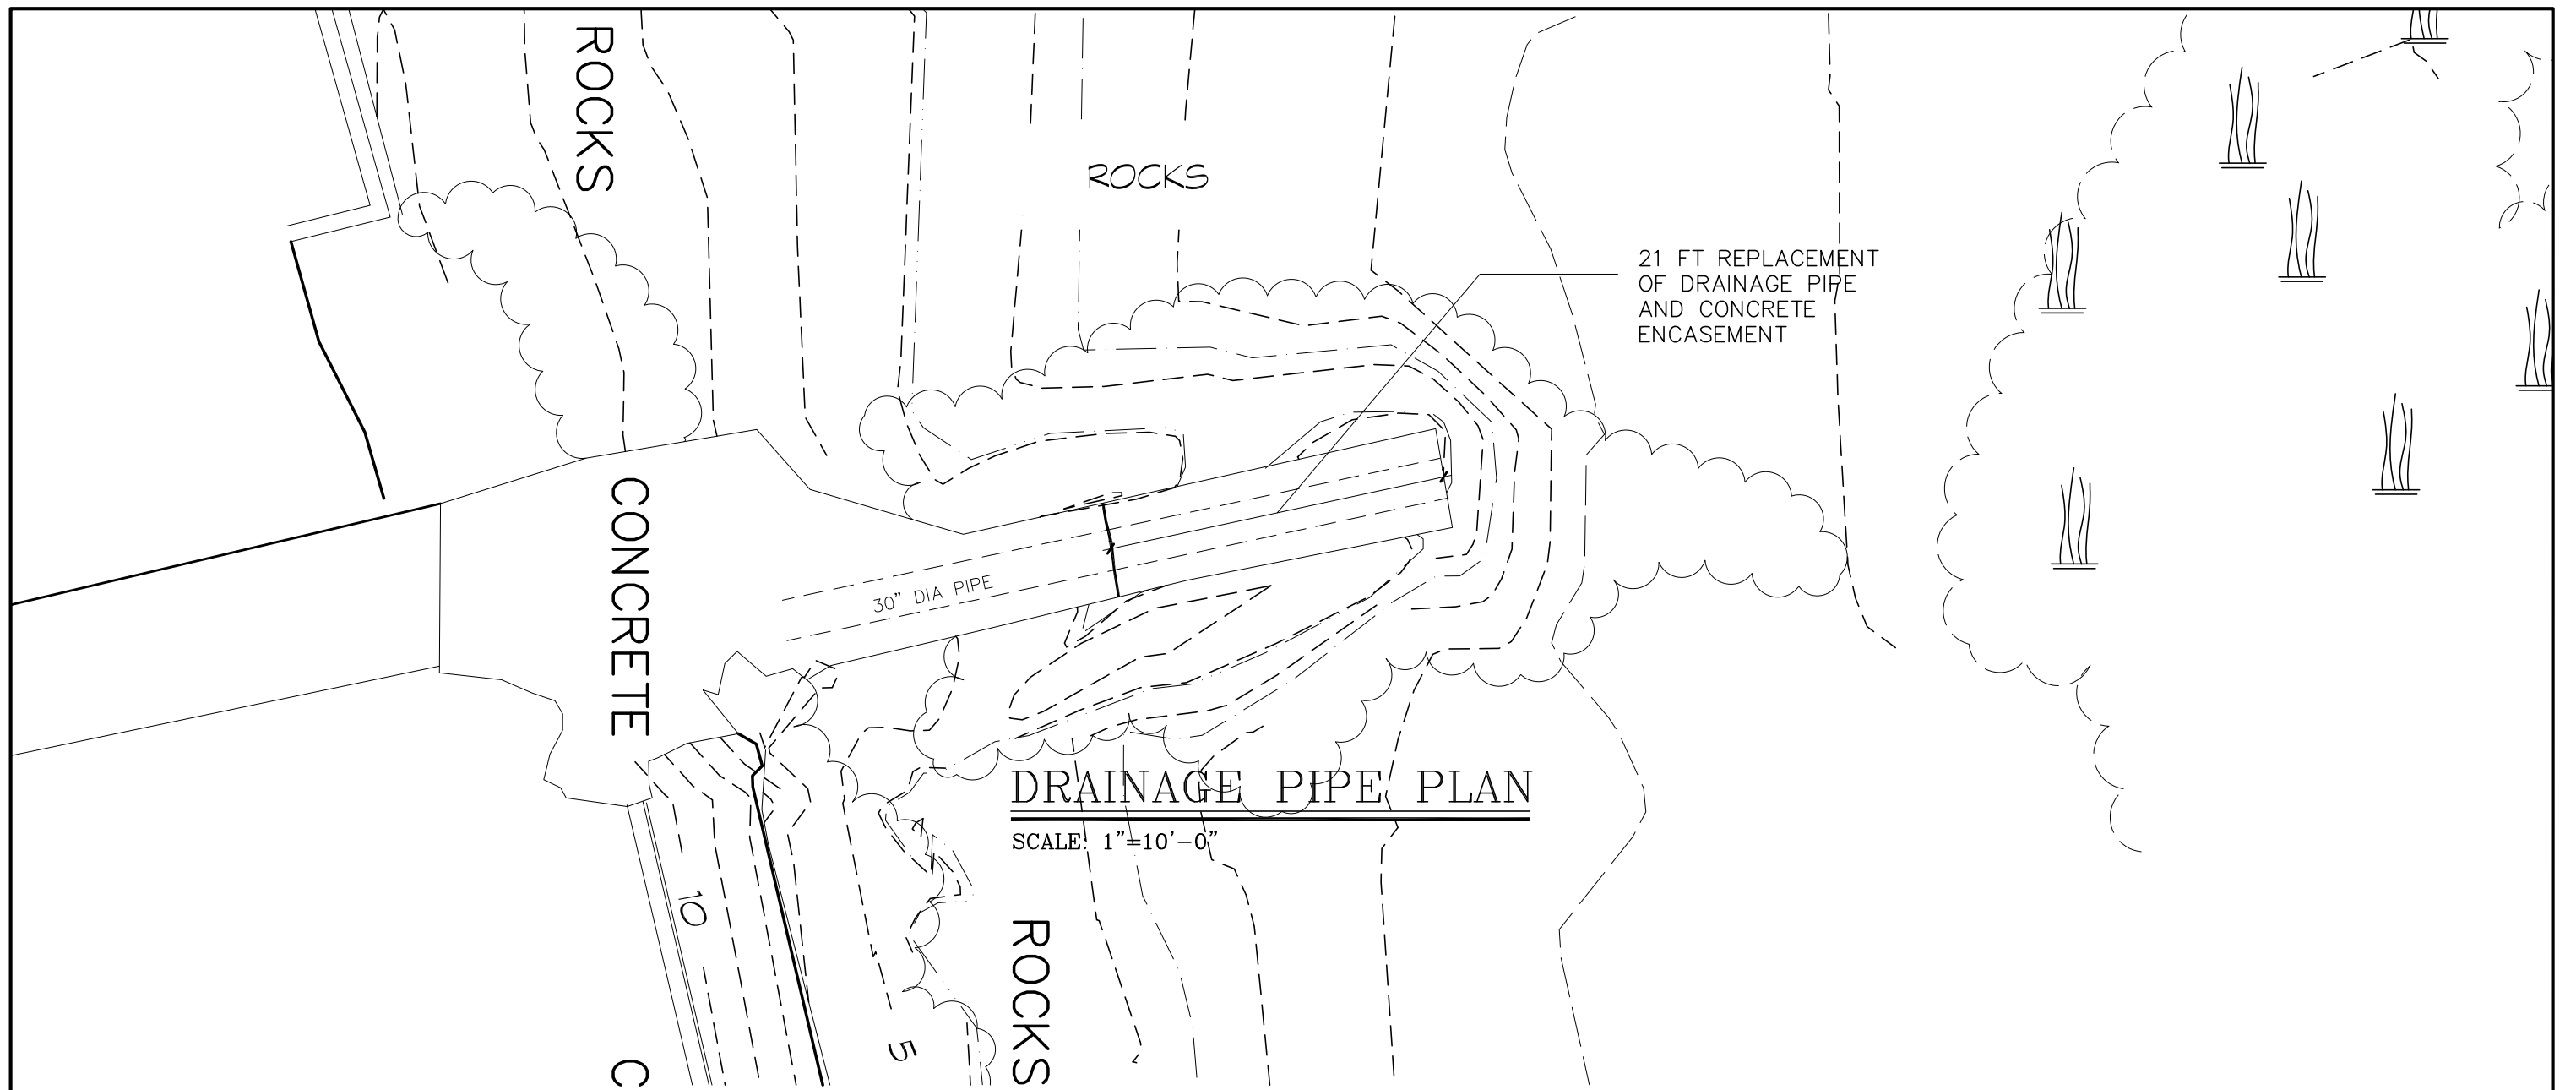
DRAINAGE PIPE CONDITION ASSESSMENT	
BLACK POINT BEACH ASSOC. NIANTIC, CT	
DATE: 12AUG20	DWG. NO.
PROJECT: #20113	SK4
SCALE: AS SHOWN	
DRAWN BY: CCB	
CHECKED BY:

With regard to the drainage pipe it would be advisable to apply for a Certificate of Permission immediately in order to preserve the right to maintain the pipe as needed. The pipe is in a delicate situation because the end section, a length of approximately 8 feet, has already become disjunct and has rotated, in position, approximately 30° counterclockwise. The system is still functional and therefore would be eligible for this maintenance work under the COP.

Pipe Repair: For Drain Pipe only - COP permit and replace last 21 feet of pipe and encasement.
